**TMS320F28335, TMS320F28334,
TMS320F28333, TMS320F28332,
TMS320F28235, TMS320F28234,
TMS320F28232 DSC**

Silicon Errata

Literature Number: SPRZ272K
September 2007–Revised October 2016

TMS320F2833x and TMS320F2823x DSC Silicon Errata

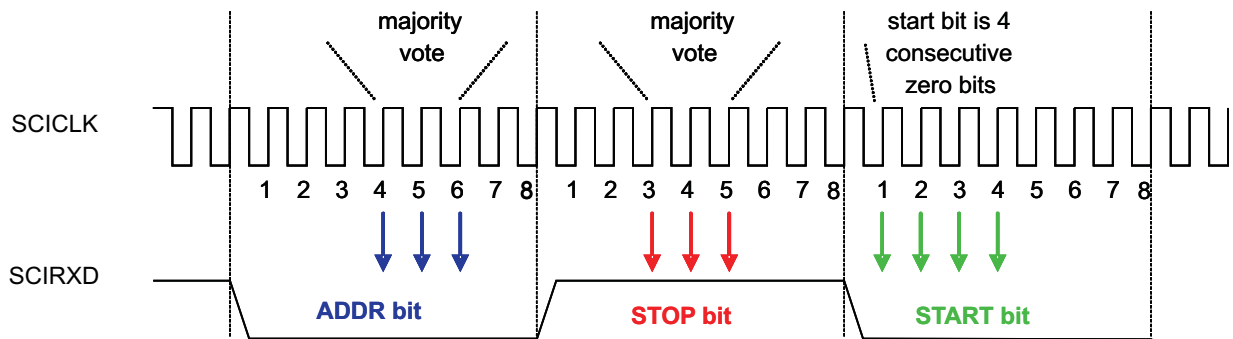
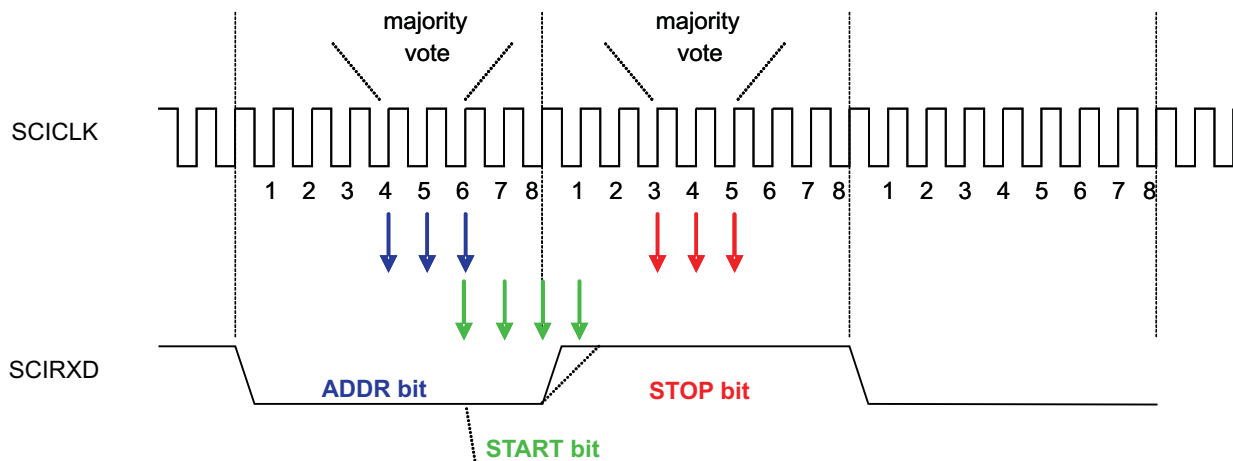
Figure 3. Difference Between Expected and Erroneous Operation of START Bit

Details SCI does not look for STOP bit after the ADDR bit. Instead, SCI starts looking for the start bit beginning on sub-sample 6 of the ADDR bit. Slow rise-time from ADDR to STOP bit can cause the false START bit to occur since the 4th sub-sample for the start bit may be sensed low.

Workaround(s) Program the baud rate of the SCI to be slightly slower than the actual. This will cause the 4th sub-sample of the false START bit to be delayed in time, and therefore occur more towards the middle of the STOP bit (away from the signal transition region). The amount of baud slowing needed depends on the rise-time of the signal in the system. Alternatively, IDLE mode of the SCI module may be used, if applicable.

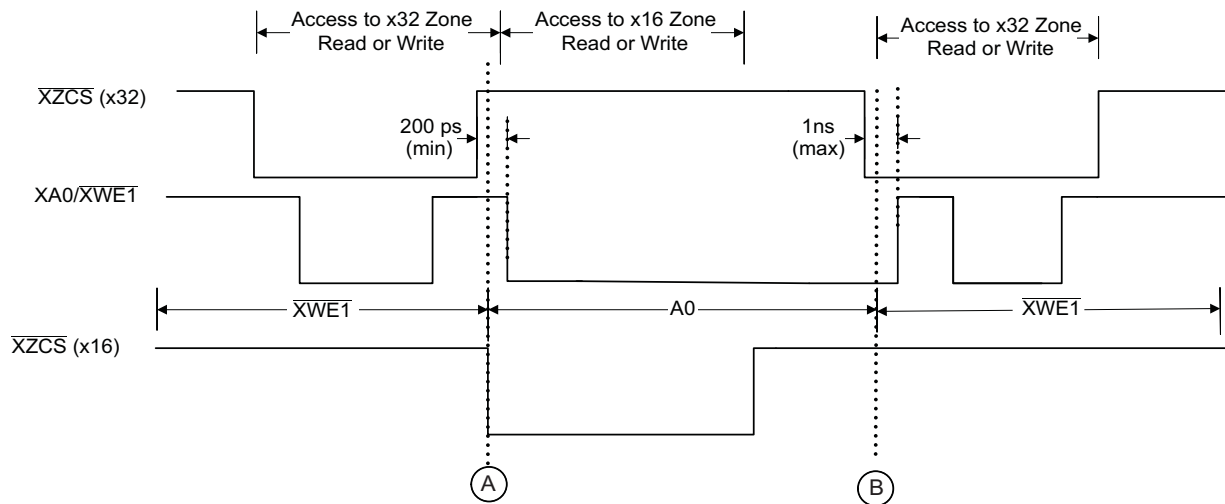
Figure 4. Behavior of Zone Chip Select Signals and XA0/XWE1

Details Figure 4 shows the behavior of zone chip select signals and XA0/XWE1 for back-to-back accesses between zones configured for different data bus widths.

- A Design simulation data indicates the delta between XZCS (x32) high and XA0/XWE1 low can be as small as 200 ps.
- B Design simulation data indicates XA0/XWE1 can stay low for as long as 1 ns after XZCS (x32) goes low.

When A0/XWE1 changes functionality, the x32 zone chip select signal (XZCS x32) changes state. Depending on the board design and peripherals attached to the XINTF, it is possible that an external memory or peripheral on the x32 zone may respond to A0/XWE1 switching as a write access. If this happens, a rogue write to the x32 zone can occur.

1. If all zones are configured for x16 operation, then no action is required.
2. If all zones are configured for x32 operation, then XA0/XWE1 will switch from XA0 to XWE1 on the first access. After the first access, the XA0/XWE1 pin will remain as XWE1. To keep external devices from responding to the XA0/XWE1 change, follow these steps when configuring the XINTF module:

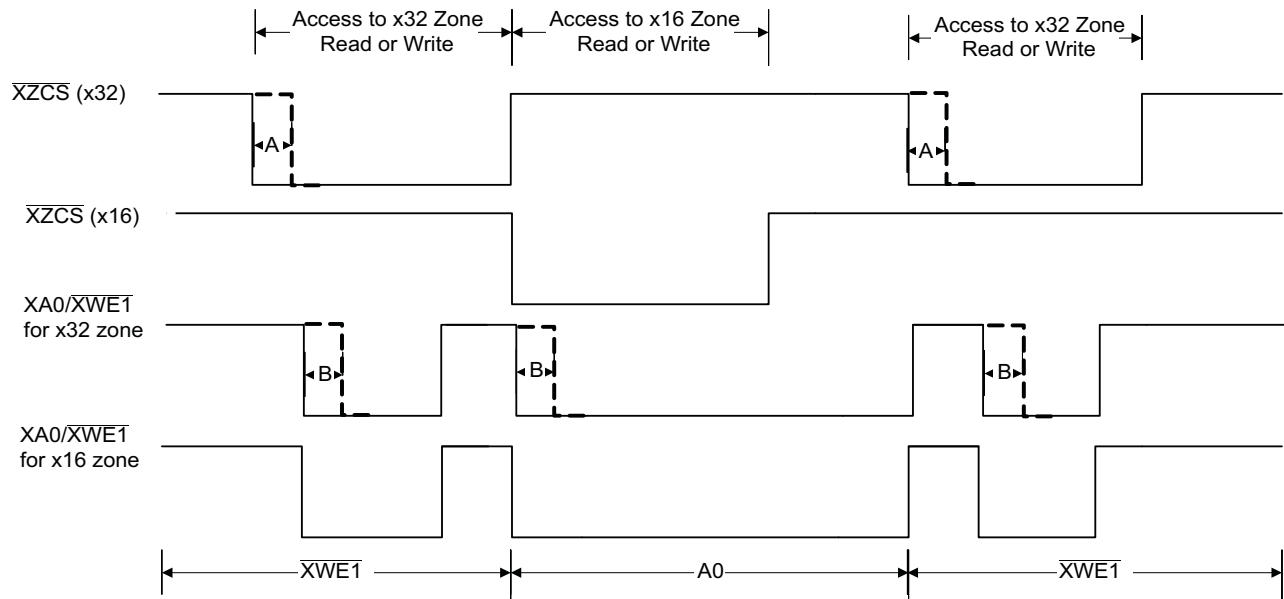
Figure 5. Behavior After Application of Delay

- A Delayed falling edge of zone chip select for x32 zone.
- B Delayed falling edge of $\overline{XWE1}$. The x16 zone will not see this delay.

- (e) Configure the GPIO MUX registers for XINTF operation.
3. Use external logic to delay the falling edge of the x32 zone chip select signal and the falling edge of the XWE1 signal as shown in Figure 5. With the delay the x32 zone chip select sees the XWE1 signal high at the critical points.

The timing configuration of the x32 zone must account for the additional delay. The zone chip select delay may require additional lead time. The $\overline{XWE1}$ delay enable may require additional active write time. In addition, specify at least 1 trail cycle for writes to the x32 zone.
